NASA TM X-3223

EFFECT OF AFTERBURNER LIGHTS
AND INLET UNSTARTS ON
A MIXED-COMPRESSION-INLET
TURBOFAN ENGINE OPERATING AT MACH 2.5

Robert J. Baumbick, Peter G. Batterton, and Carl J. Daniele Lewis Research Center Cleveland, Ohio 44135

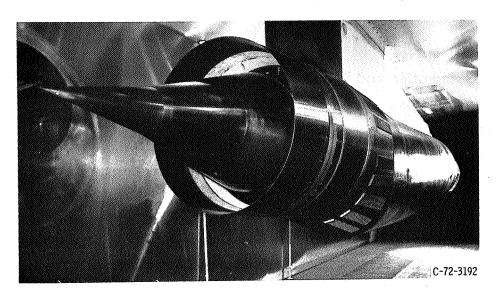
Figure 1. - Axisymmetric inlet and TF-30 P-3 nacelle.

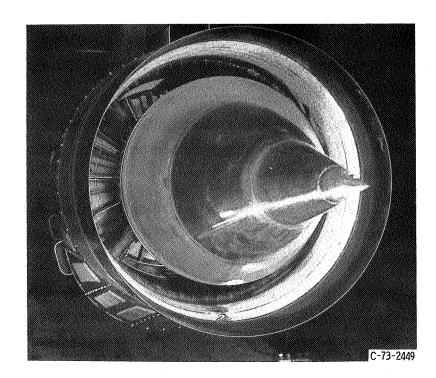
Figure 2, - Inlet and TF-30 P-3 fan.

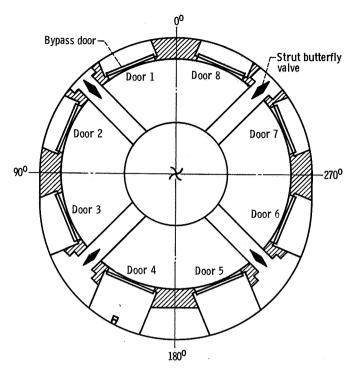
Figure 3. - View of inlet looking downstream showing bypass doors and centerbody bleed flow struts.

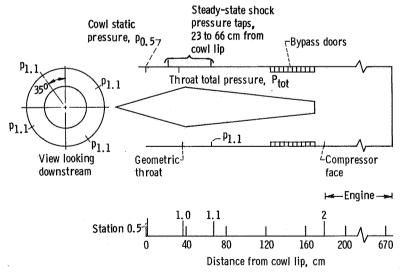
Figure 4. - Location of steady-state and dynamic instrumentation and station numbers on inlet.

The transient pressures were measured with strain-gage transducers connected to the cowl with short tubes. As shown in figure 4, there is a plane containing dynamic pressure transducers located 66 centimeters from the cowl lip (station 1.1). The four transducers in this plane, spaced 90° apart, were electrically averaged. The average pressure is identified as $p_{1.1}$. In addition to these transducers, others were used to measure the total pressure at the inlet's geometric throat (P_1) and the static pressure on the cowl near the lip $(p_{0.5})$. The ratio $p_{0.5}/P_1$ was used as the inlet unstart sensor.

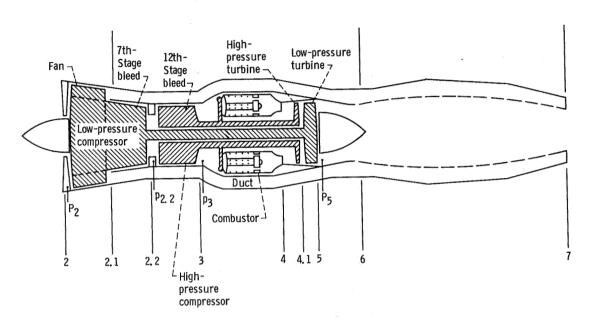
Figure 5. - Engine stations and instrumentation locations.

The engine used in this investigation was a Pratt & Whitney TF-30 P-3. The TF-30 is an axial, mixed-flow, augmented, twin spool, low-bypass-ratio turbofan engine with a variable area convergent primary nozzle. A schematic of the engine is shown in figure 5. The engine stations are shown in this figure. (A more detailed description of the engine and its control system are presented in ref. 4 and will not be included here.) All engine pressure signals were sensed by strain-gage pressure transducers and were obtained by tapping off of the pressure tubes going to the main fuel control. The high-pressure turbine-inlet temperature \mathbf{T}_4 is the manufacturer's signal, which is based on the temperature rise across the compressors and the low-pressure turbine-discharge temperature. Fuel flows were measured by turbine flowmeters.

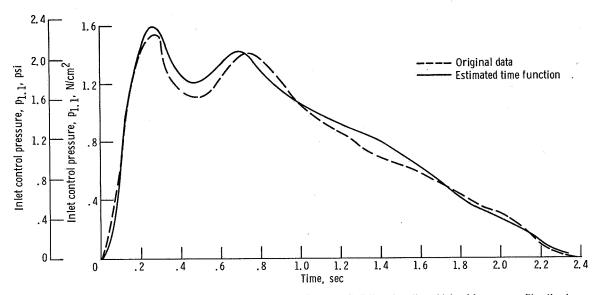
Figure 8. - Comparison of scaled $\,p_{1,\,1}\,$ signal with explicit time function obtained from curve fit estimate.

The expression shows that there are dominant frequencies at approximately 0.2 and 2 hertz. Figure 8 shows both the actual data obtained from the strip chart and the approximation based on the expression. It compares reasonably well with the $p_{1.1}$ trace.

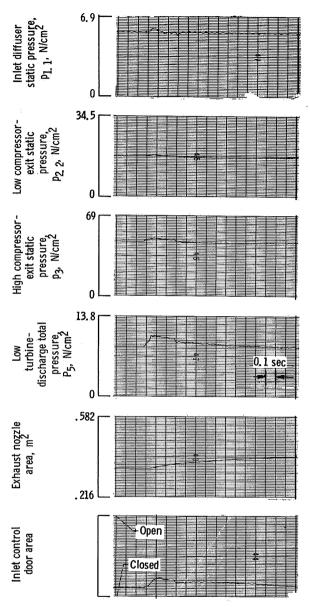
Figure 9. - Afterburner lightoff with inlet on control using fast bypass doors for shock control.

Figure 9 shows an afterburner light with inlet control using the 80-hertz doors with the shock at its normal operating point. From this figure an estimate of the peak flow rejected by the engine as a result of the afterburner light can be obtained. Since the bypass doors are choked, the flow bypassed is proportional to the change in door area (ignoring the pressure effect). The maximum flow bypassed is approximately 4.7 kilograms per second (corrected). The engine corrected airflow is approximately 70 kilograms per second. The peak bypass flow during the transient is approximately 6 percent of the engine flow. The events recorded in this figure are similar to those discussed for figure 6 with the exceptions that there is inlet control and that the shock is at its normal operating point.

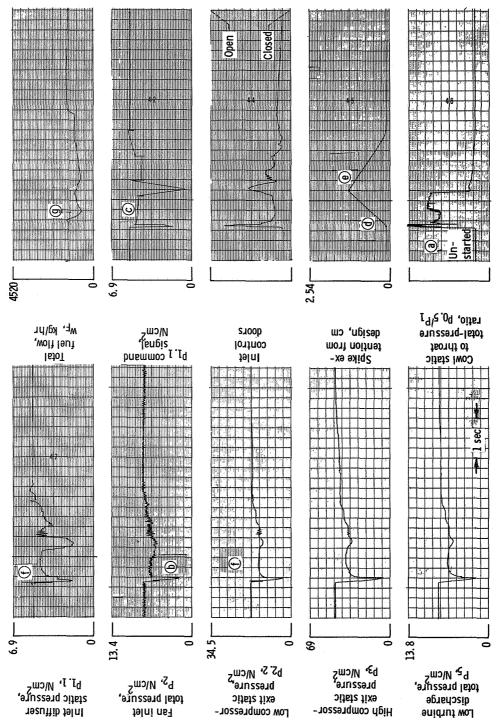
Figure 10. - Inlet unstart using strut valves to unstart (nonafterburning).

Figure 10 shows time traces of inlet-engine variables for an inlet unstart-restart cycle. A proportional-plus-integral control was used for terminal shock control and an automatic restart feature was provided. (See ref. 5 for details on the shock control and restart control.) Closing the centerbody bleed valves momentarily initiates the unstart. The inlet unstarts (point a) as indicated by the cowl static- to throat total-pressure ratio $(p_{0.5}/P_1)$. The unstart results in a drop in pressure recovery as noted by the P₂ trace (b). Inlet restart action is initiated. A complex function of spike position was used as the controller shock position command signal during the restart cycle (c). This function insures that the inlet will not go into buzz. The spike is commanded to extend (d). Restart occurs when the proper capture flow to throat flow ratio is achieved and the spike is commanded to return to its operating point (e). The reduced pressure (caused by the unstart) at the compressor face causes the engine to stall. A large hammershock is noted in the inlet $(p_{1-1}$ trace) and is also detectable on the low pressure discharge trace $(p_{2,2}; fig. 10, point f)$. Stall recovery is completed during the inlet restart cycle. The engine control reduces fuel flow (g) to prevent excessive turbine inlet temperature.

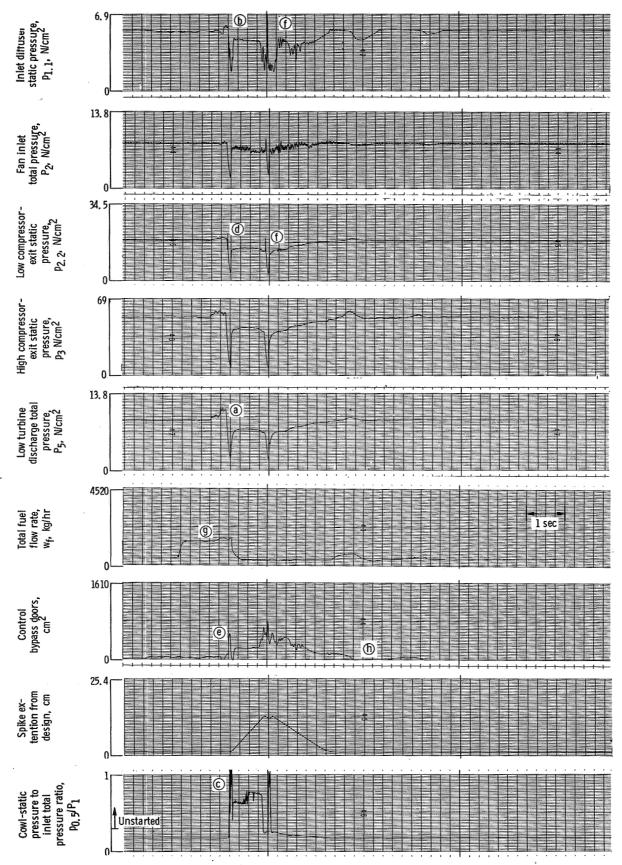
Figure 11. - Inlet unstart induced by afterburner light with slow inlet control doors.

Figure 11 shows an inlet unstart produced by an internal disturbance, namely, an afterburner light. These data were taken with an active coupled control (see ref. 4) and with slowed up bypass doors. For the data shown the unstart produced by the afterburner lightoff shows different characteristics compared to the unstart produced by the upstream disturbance (fig. 10). The afterburner light (a) causes the terminal shock to move upstream (b). Before the control can act the shock is expelled, resulting in an inlet unstart (c) and an engine stall with a more noticeable hammershock occurring on the $\mathbf{p}_{2.2}$ trace but not evident on the inlet pressure trace $\mathbf{p}_{1.1}$ (d). With the onset of the disturbance, the coupled engine control could not respond fast enough in the transient sense, and the bypass doors attempt to compensate by opening (e). A second engine stall occurs in this case with large pressure hammershocks occurring in the engine and inlet (f). The second stall occurs at the restart point, but the engine recovers and returns to its operating point.

The reason for the second stall occurring at the restart point may be that at the restart point the distortion is highest. The total fuel flow increases before the light-off because the flowmeter measuring fuel flow was located upstream of the spray nozzle manifold. The fuel flow trace (fig. 11, point g) indicates the additional amount of fuel required to fill the fuel manifold. The integrated control was active for this test and the bypass doors closed again after the transient ended (h).

The second stall that occurred, as shown in figure 11, seemed to occur with either the slowed down doors or 80-hertz bypass doors but did not occur consistently. However, when the second stall occurred, a large pressure hammershock was noted in the inlet. No engine blowouts were encountered when the inlet unstarted but the engine did stall but recovered from the stall.
